Lightning Strike Effects on Full-Depth Scarf Repairs

Alex Nguyen, Justin Hla, Bilal Husain, Yushi Nakaoka, Matt Pflipsen, & Jeaziree Salise

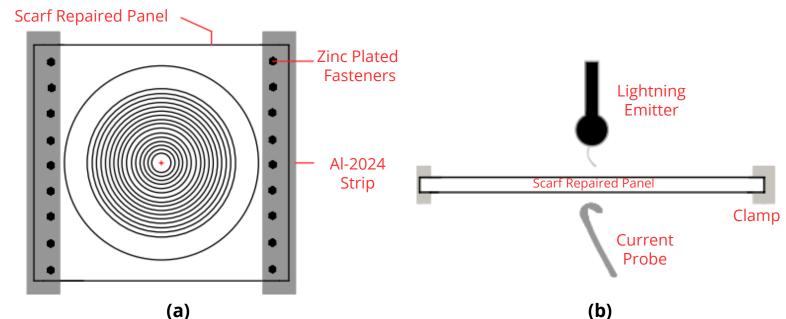
Figure 3. (a) The grounding strap procedure for lightning testing (b) and the lightning test apparatus.

To simulate lightning damage, each panel was struck with 100 kiloamperes of current at a point slightly off-center of the repair patch. At the point of contact, a nick of paint was chipped off to ensure the current interacted with the inter-woven wire fabric (IWWF). These tests were facilitated by Boeing's lightning testing lab in Seattle.
